Laboratory Hood Hydrogen Fire Incident

Bob Zalosh¹ and Nick Barilo²

Presented at the 25th Hydrogen Safety Panel Meeting, New Orleans, LA, April 2019

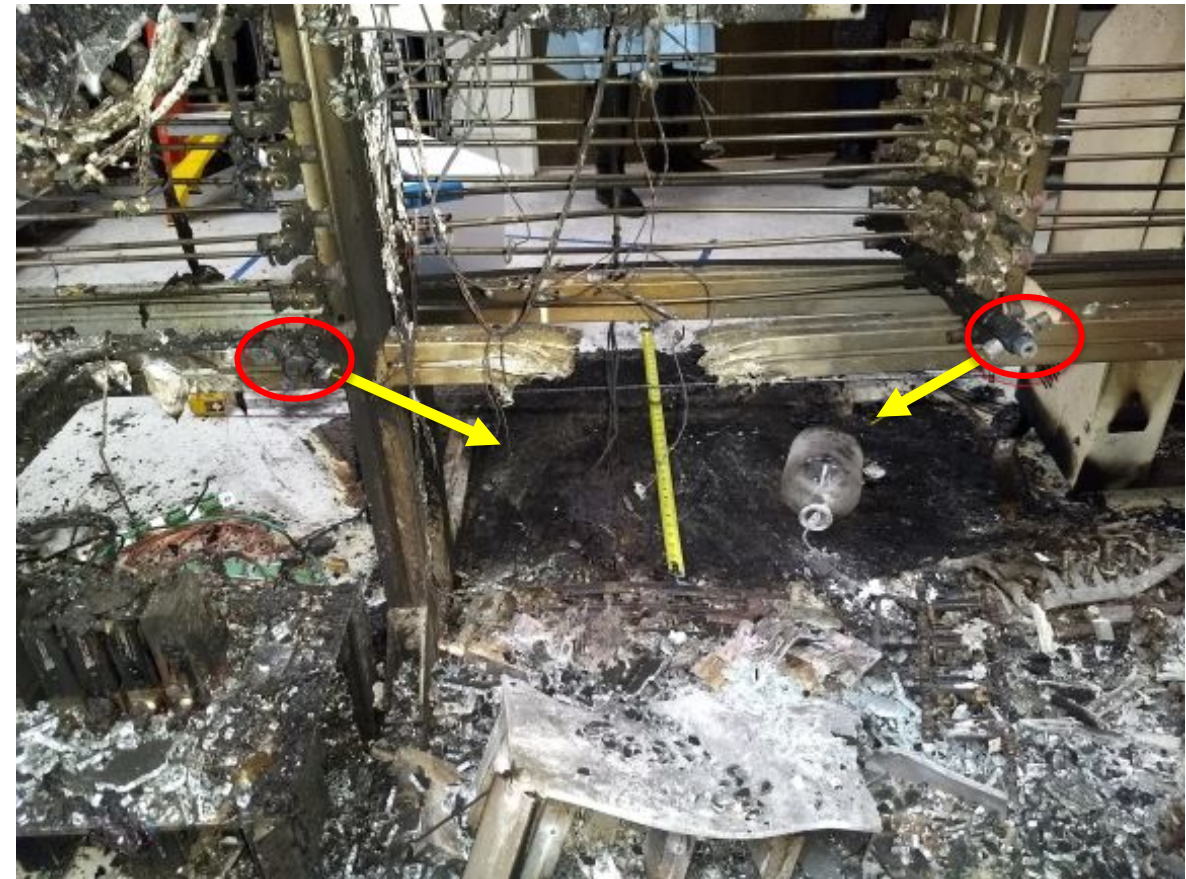
Doors removed to see interior damage

Suspected hydrogen release site:
Arrows denote possible release location and jet orientation

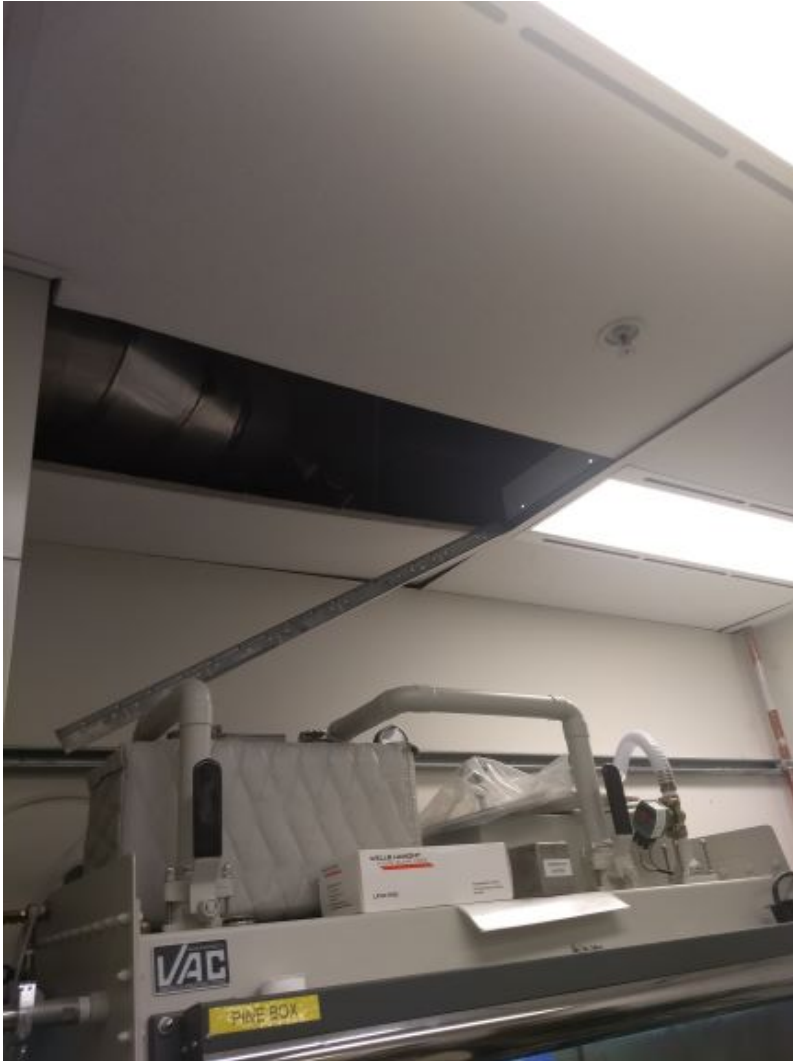
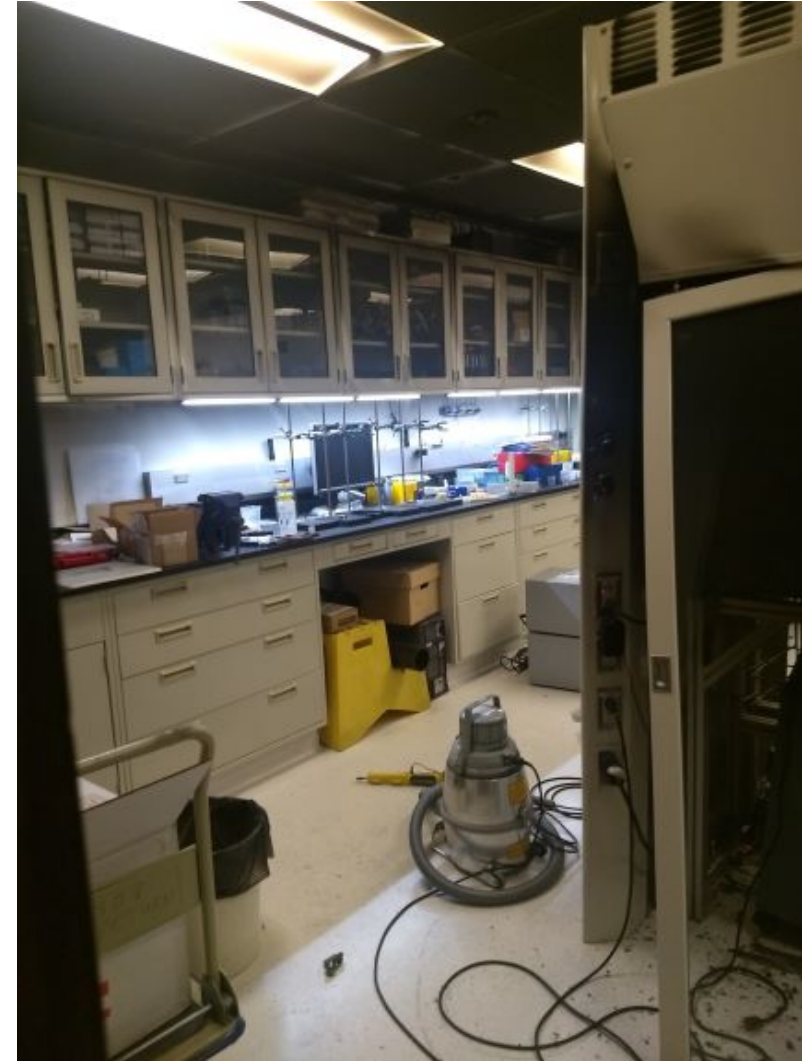
Minor Lab Damage Photos

Ceiling panels displaced by low overpressure in lab: could be caused by partial volume deflagration at ignition or by ruptured cylinder blast wave

Charring and smoke deposits on ceiling and light fixtures from burning plastics in hood.

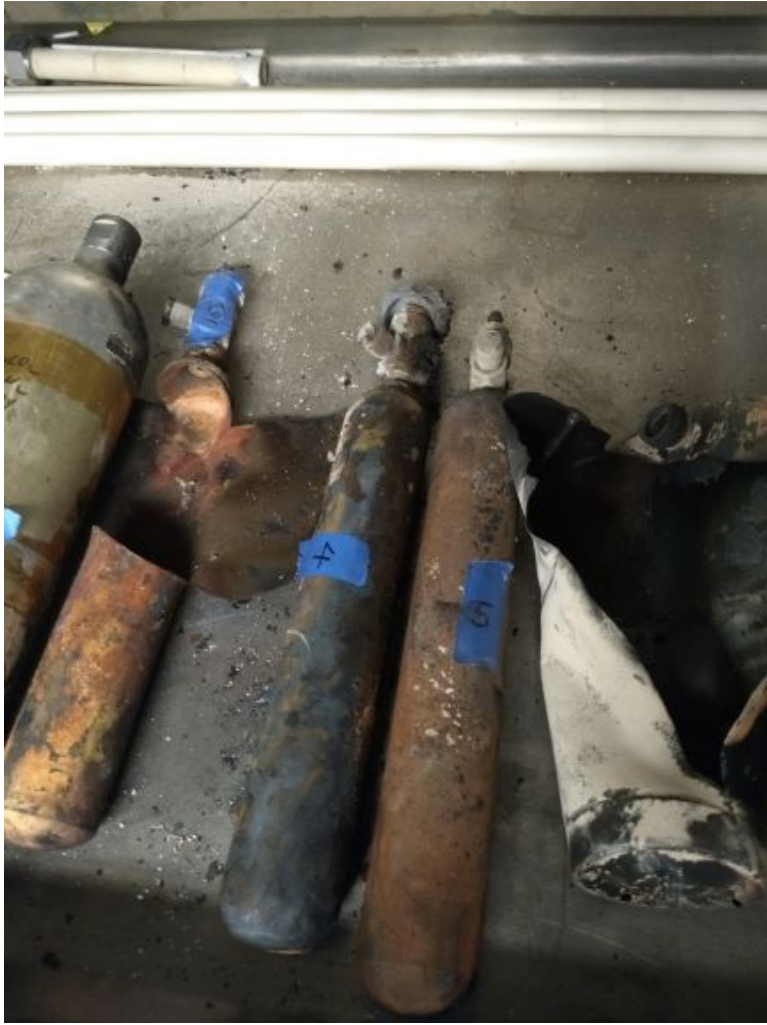
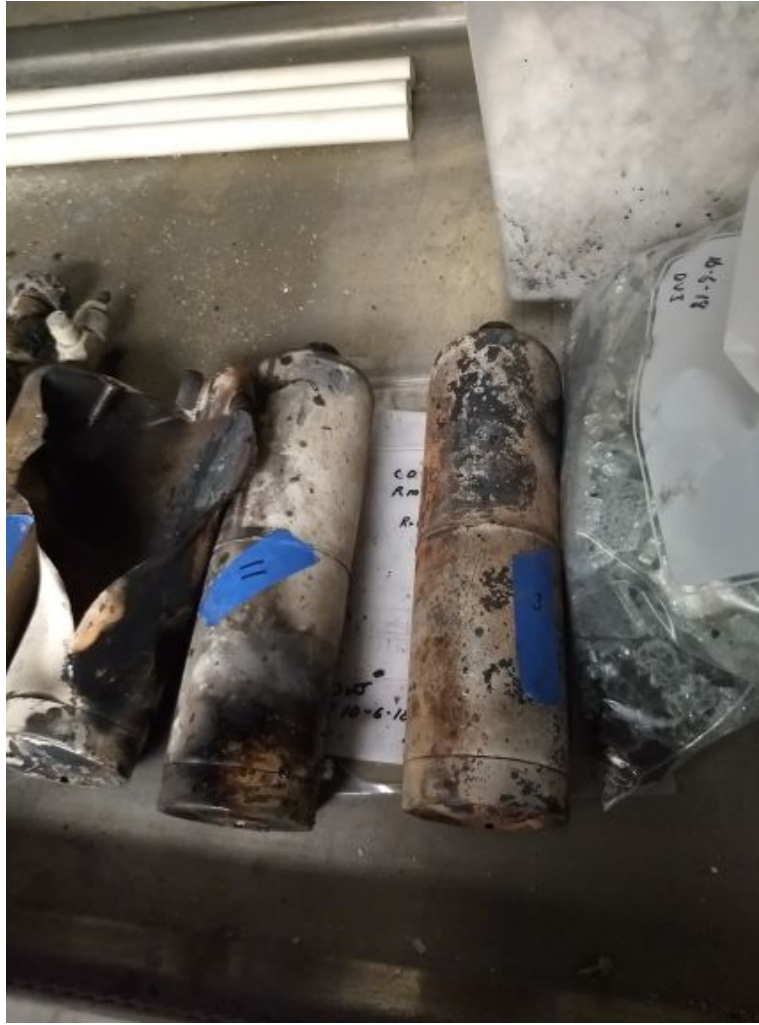
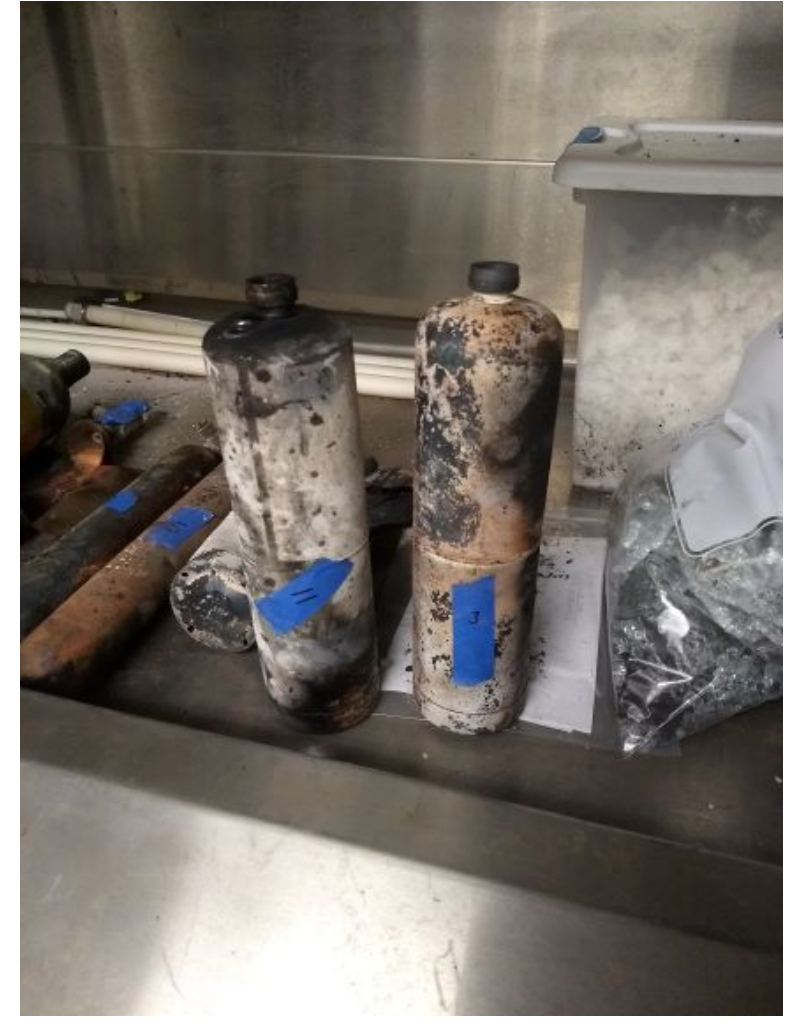
Remains of Small Cylinders that were in Tote on Hood Floor

- ▶ Reevaluate and/or strengthen policy related to storage of compressed gas cylinders near elevated temperature operations.
- ▶ Reevaluate and/or strengthen policy related to storage of general materials (e.g. totes with contents) inside hoods or ventilated enclosures containing elevated temperature related work.

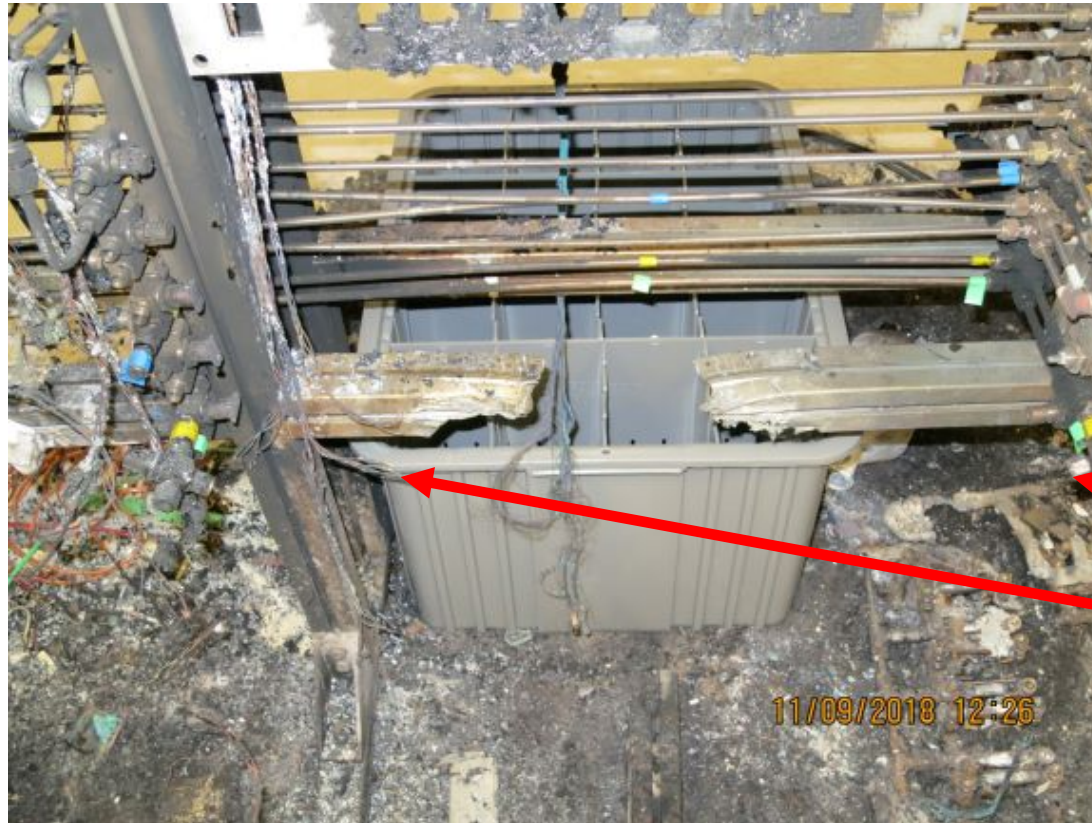
Location of Cylinder Tote Near Suspected Release Site

Edge of exemplar tote is directly under hydrogen tube fittings that were suspected release sites; Tote would have melted and burned; producing exposure fire directly on cylinders.

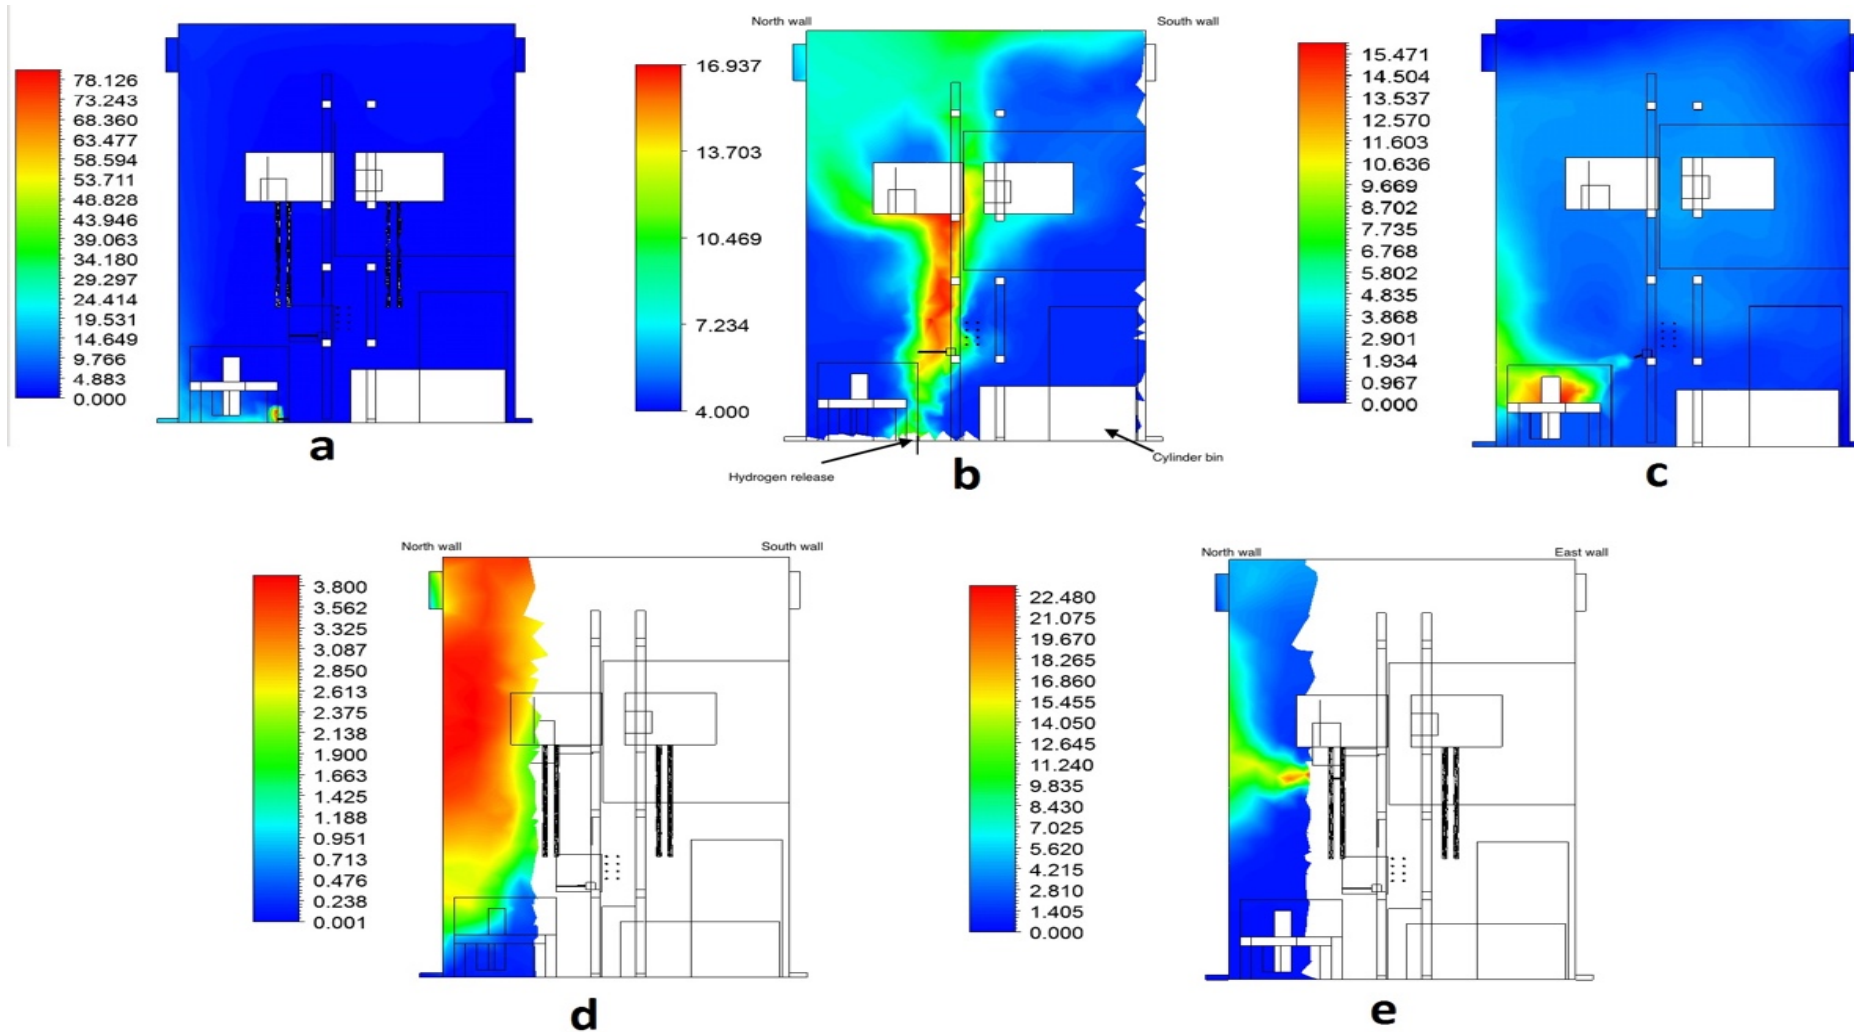
Hydrogen Dispersion Calculations: H2 Concentration Distributions

Small flammable regions near release sites and extending up to furnace in one scenario.

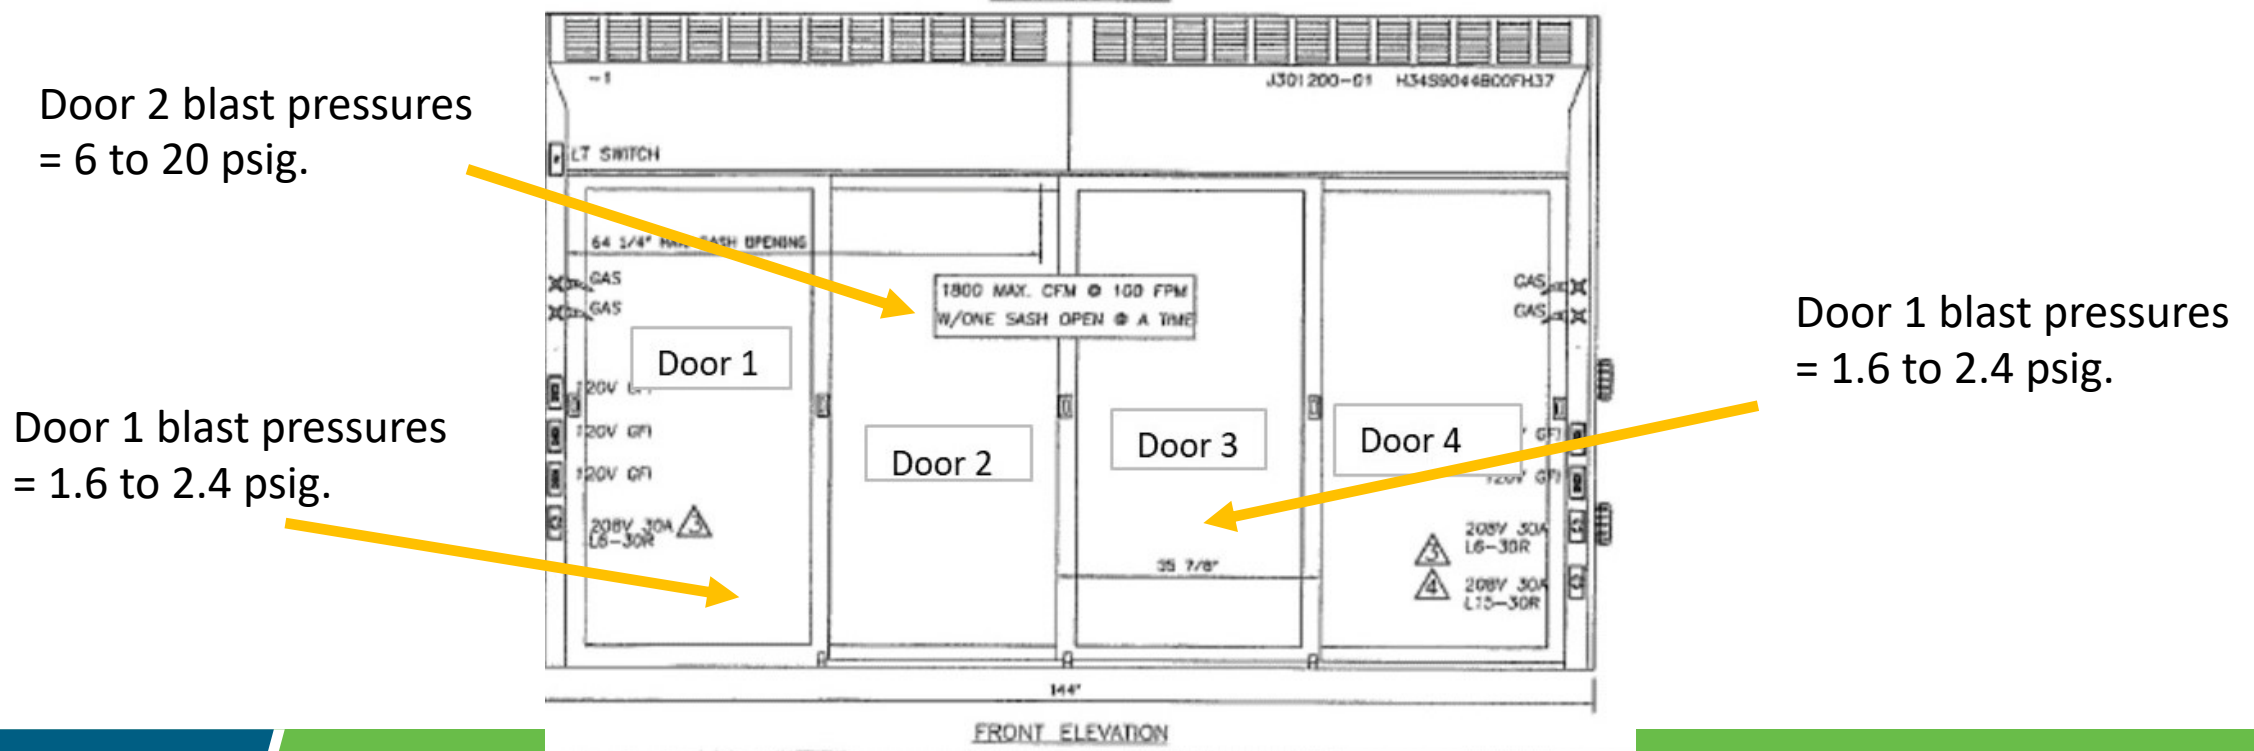
Propane Lecture Bottle Blast Wave Analysis

- Estimated bottle rupture pressure due to fire exposure = 4.4 to 7.1 MPa.
- Blast wave pressures at doors shown in drawing below.
- Tempered Glass Breakage Pressure > 2.7 psig.
- Expect glass breakage on Door 2, but not on Doors 1, 3, 4.
- Consistent with door damage observations.
